Lightner Creek Watershed Evaluation Report

**Lightner Creek Watershed Group
Durango & La Plata County**

**Basin Hydrology, Inc.
Durango, CO**

January 24, 2011

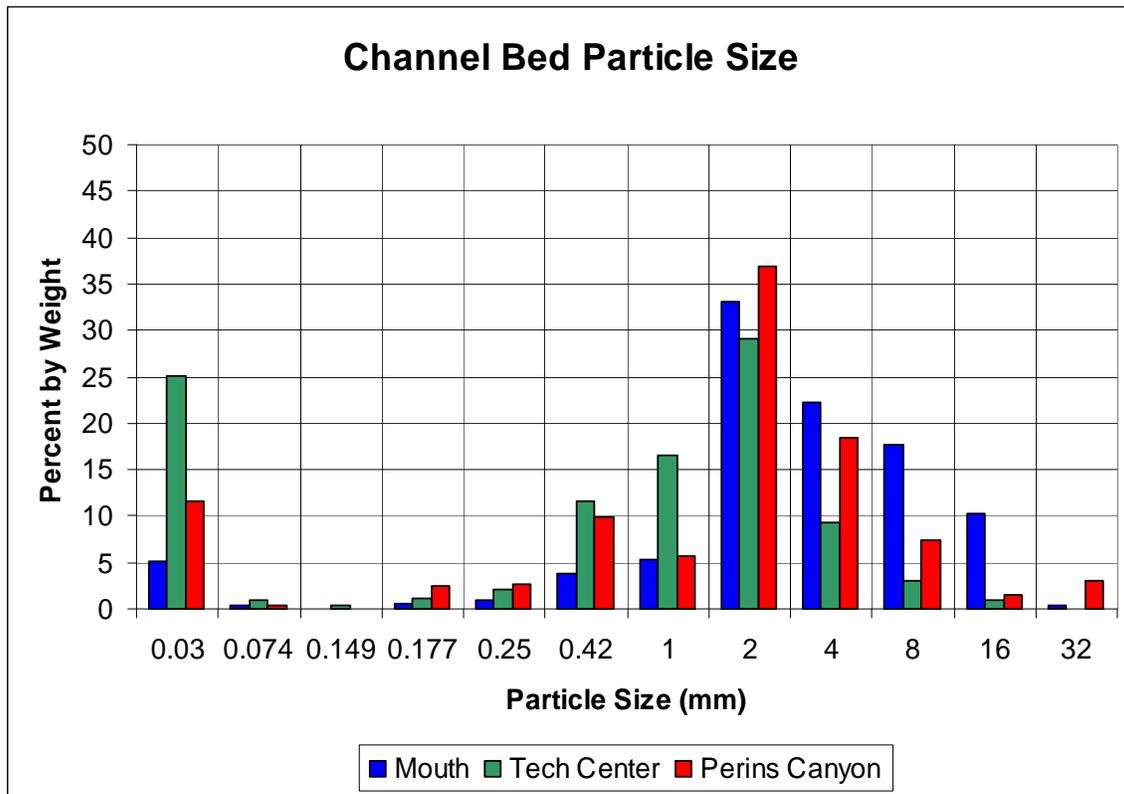
The Channel Bed Particle Size chart quantifies the percentage of each particle size class at each sample site. Common to all three sites is the relatively small size of materials present. At the Tech Center site, ~ 25% of the material is smaller than 0.074mm. Very fine sand size particles are in the 0.1mm to 0.05mm range, silt is in the 0.05 to 0.002mm range and clay is finer than 0.002mm. It is likely that the majority of the material passing through the 0.074mm screen is silt and clay. These size particles are easily transported and remain in suspension for long periods once mobilized, contributing to turbidity.

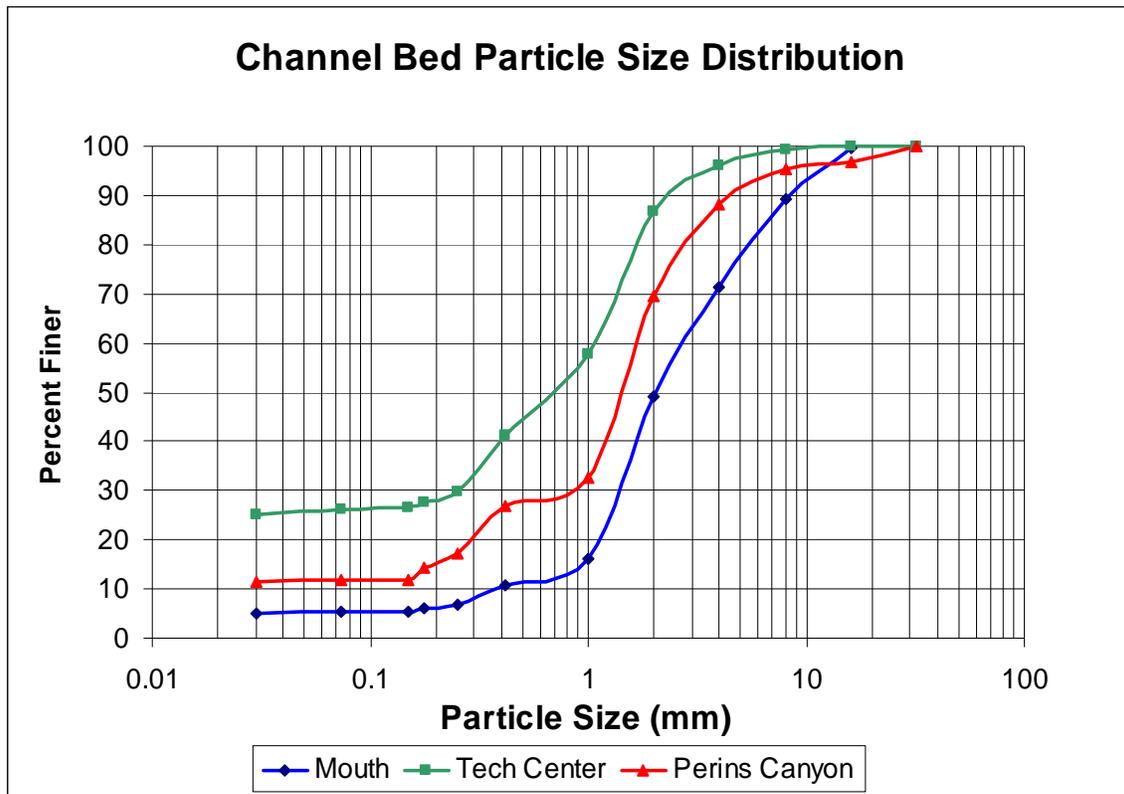
The Channel Bed Particle Size Distribution chart shows the distribution of particle size classes based on their accumulated occurrence. The largest particle sizes measured were 32mm for both the Mouth and Perins Canyon. In general, the Mouth has the largest particle sizes, with Perins Canyon intermediate and the Tech Center the smallest particle sizes. The mean particle sizes are approximately 2mm, 1.5mm and 0.7mm for the Mouth, Perins Canyon and Tech Center sites, respectively. Despite numeric differences, these are all relatively small particle sizes. The Mouth site has the coarsest material, which is to be expected as there is little opportunity for fines to settle out due to the scouring affects of the Animas River during non-low flow conditions.

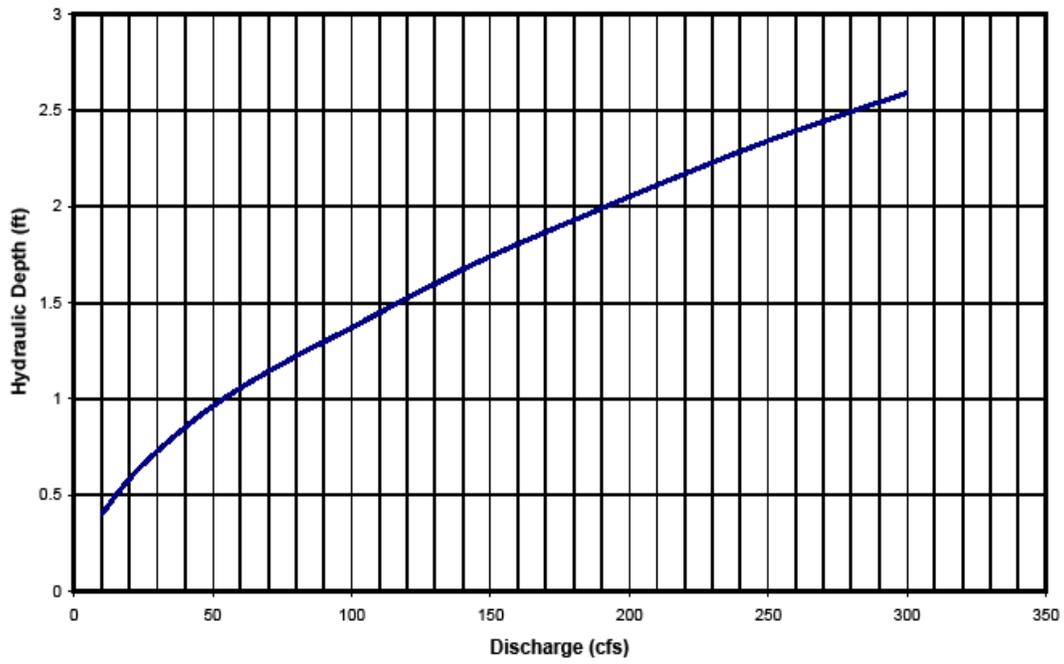
Lightner Creek - Hydraulic Depth vs Discharge

The channel cross section and longitudinal profile surveyed ~ 150' upstream of the Dog Park bridge were used to generate stage versus discharge and discharge versus moveable particle size relationships. These relationships are presented below. The bankfull discharge (*the flow that occurs, on average, every two out of three years*) is estimated to be ~ 200 cfs, corresponding to a depth of ~ 2.0' (see Hydraulic Depth versus Discharge plot below). The stage (hydraulic depth) versus discharge relationship provides some basic information on the hydraulic capacity of Lightner Creek for low to moderate flows. This relationship was then used to develop the stage (hydraulic depth) versus moveable particle size relationship. The mean slope at the Dog Park site is ~ 1.7%.

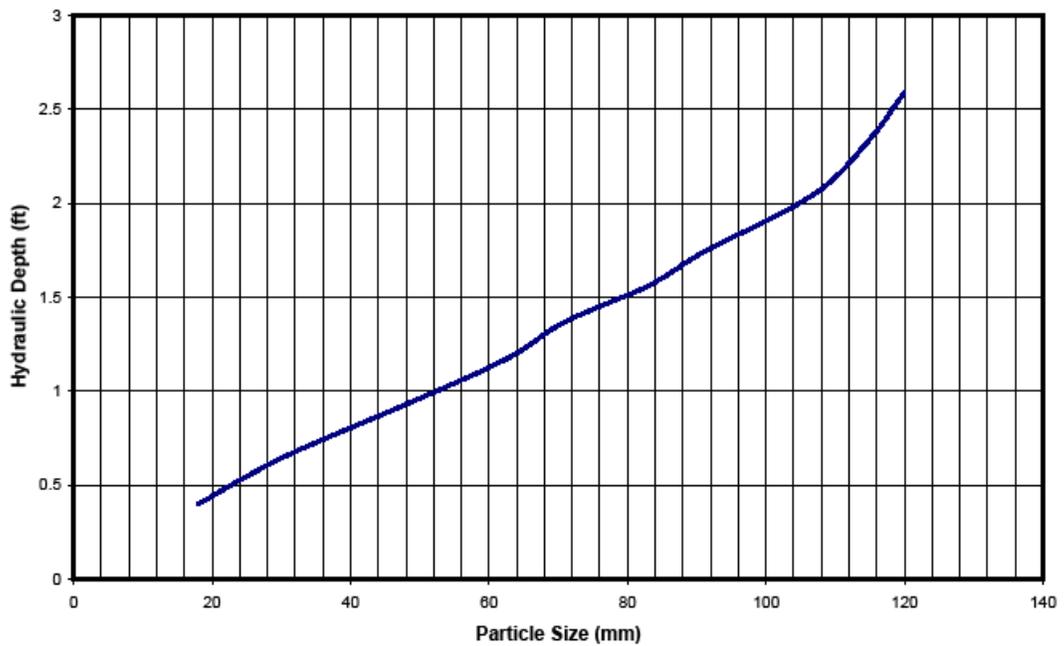
Lightner Creek - Hydraulic Depth vs Moveable Particle Size

The Hydraulic Depth versus Moveable Particle Size plot shows the size of particles predicted to move during a specific stage. Channel bed shear stress was calculated for various stages and converted to moveable particle size using the Shields Diagram.

Based on the above chart and the particle size distributions for all three sediment evaluation sites, it is clear that all the measured particle sizes are potentially moved during even relatively low discharge rates. This indicates that sediments discharging from the Tech Center and Perins Canyon watersheds or other source areas with similar particle distributions along Lower Lightner Creek are easily transported towards, if not to, the mouth of Lightner Creek during even modest runoff events. Assuming the bankfull discharge of ~ 200 cfs, large volumes of fine grain materials can be transported along the Lightner Creek channel and into the Animas River. Considering that ~ 25% of the sediments measured at the Tech Center site and ~ 12% of the sediments at the Perins Canyon site are silt size and finer, these two watersheds could be a significant source of fine textured sediments that are deposited at the mouth of Lightner Creek and also of silt and clay sediments that remain in suspension beyond the mouth of Lightner Creek. Not all of the sediments originating from these two source areas, or any other source area, necessarily make it to the Animas River in a given runoff event. Some settle out in back water areas, pools and in overbank areas. Sediments in these areas can easily be remobilized during subsequent runoff events.
